**RESC19-07-2 RUBY BAY SEAWALL AT BROADSEA AVENUE -
DRAINAGE/MAINTENANCE ISSUES****Information Only - No Decision Required**

Report To: Engineering Services Committee
Meeting Date: 4 July 2019
Report Author: Jamie McPherson, Transportation Manager
Report Number: RESC19-07-2

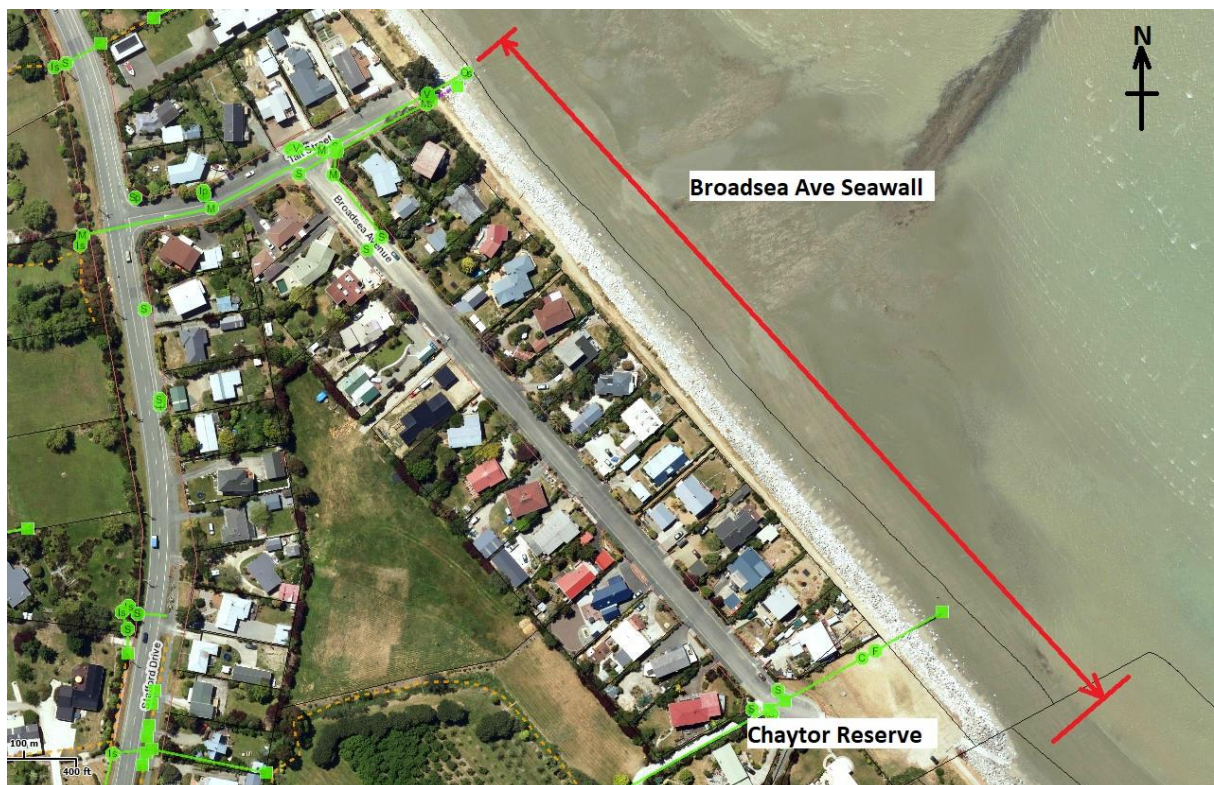
Figure 1. Broadsea Ave Seawall Location, and existing stormwater infrastructure

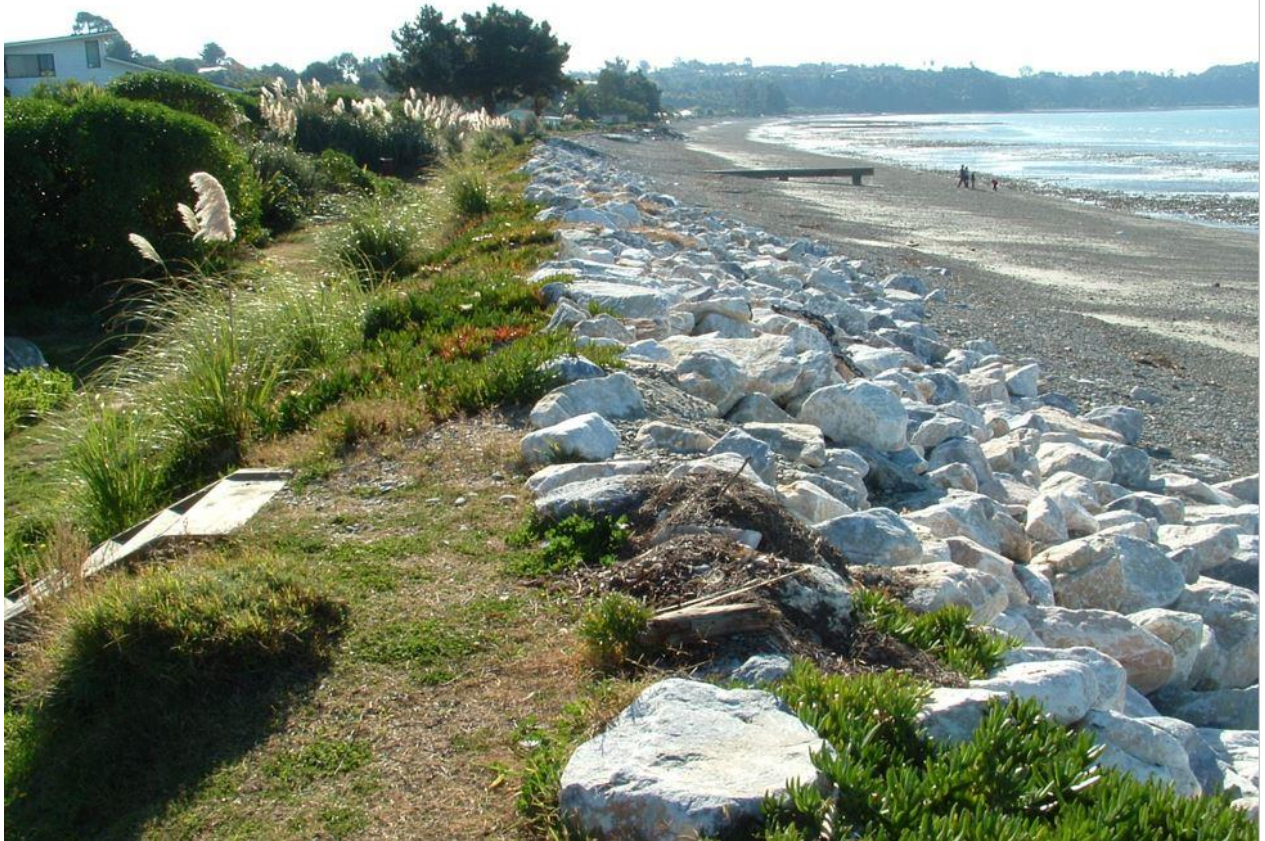
Figure 2 – Seawall in 2004

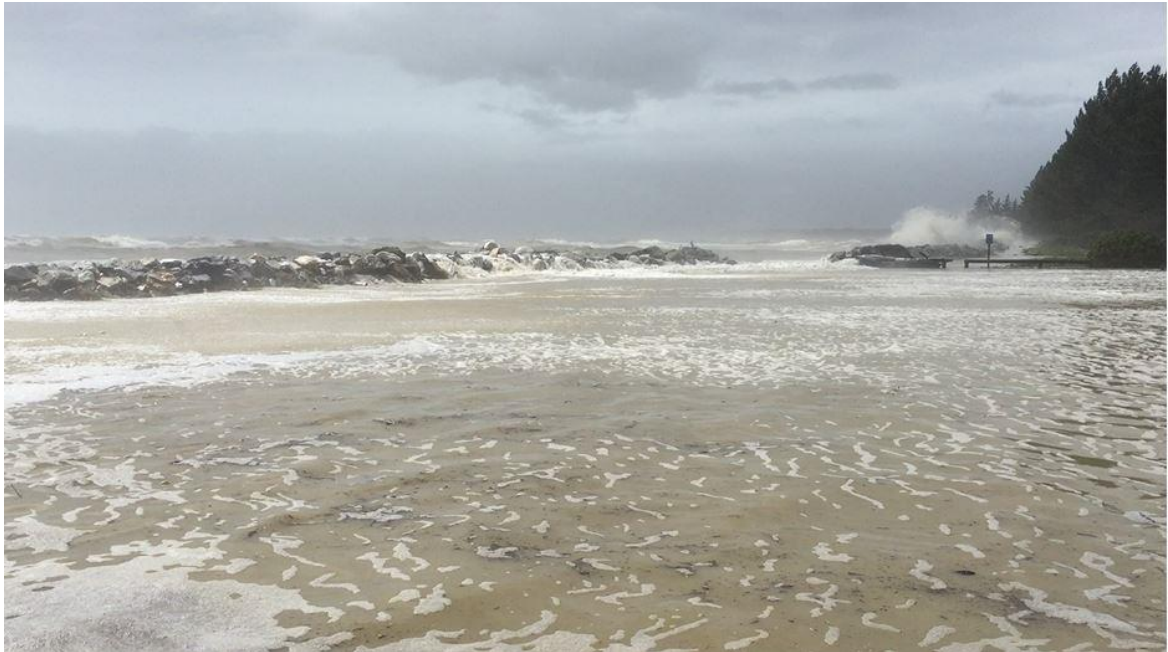
- 4.22 Figure 3 below shows Chaytor Reserve looking towards the ramp during ex-Cyclone Fehi. It is evident that the sea level was so high that there was little opportunity for seawater behind the wall to flow out to sea via the ramp.

Figure 3 – Chaytor Reserve during ex-Cyclone Fehi February 2018, looking towards boat ramp.

- 4.23 Council will be delivering improvements to the stormwater system in the coming year. New pipes and an improved stormwater channel will be constructed between Stafford Drive and Broadsea Avenue, in conjunction with the water and wastewater work in the area. There is also scope for minor improvements for stormwater intakes as part of this work. A second outlet to the coast was initially considered for this area, but was likely to deliver minor stormwater benefits and insufficient budget was available so has not been progressed.
