Rob O'Grady's walk around Ruby Bay. Summary of findings.

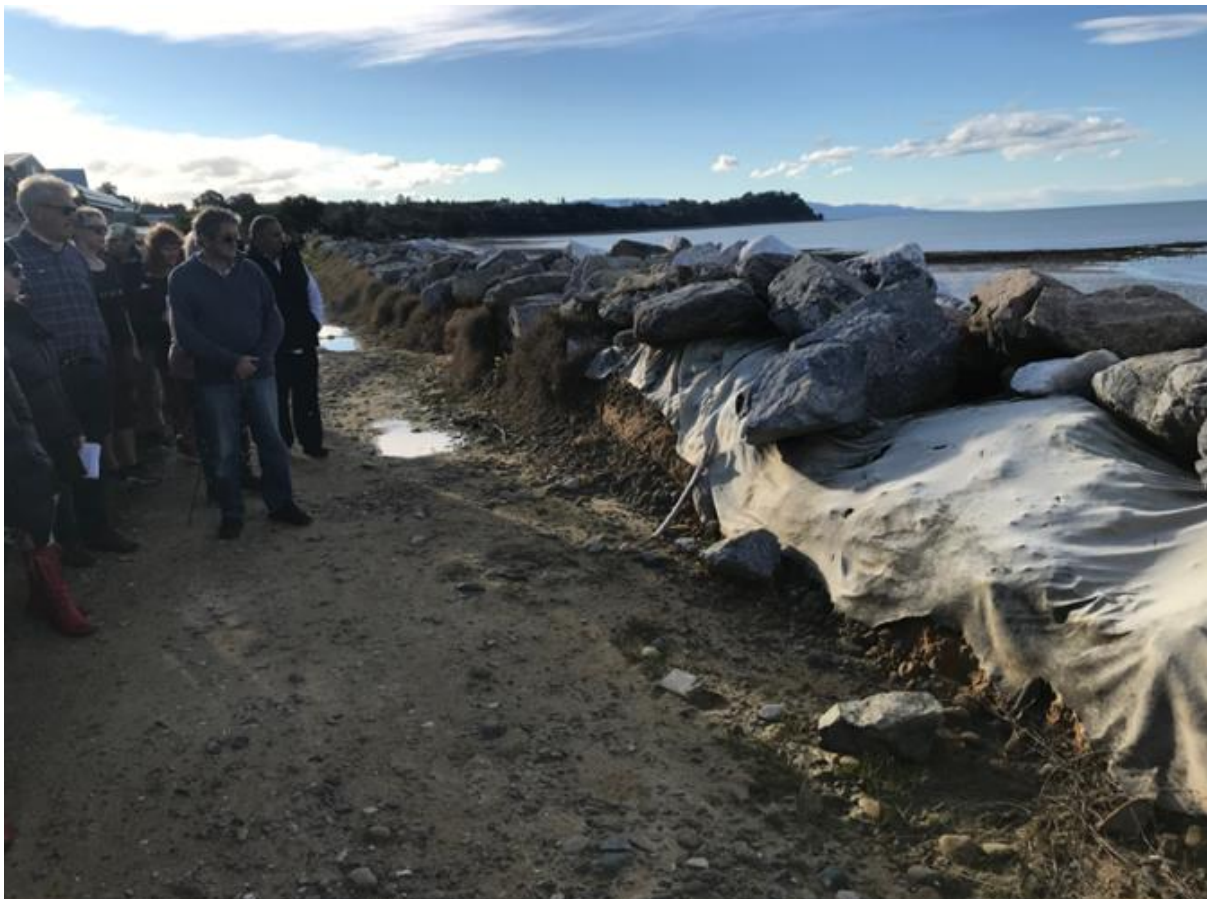
It was recounted that during Cyclone Fehi most of the flood water was generated by waves splashing up over the sea wall, as opposed to waves surging over the wall. It was suggested that if the water splashing over the sea wall could have flowed back through the sea wall then flood waters would not have accumulated to the same extent. The seawall effectively acted as a dam.

It was suggested that, if the part of the sea wall that extends above the walkway was made of large rocks with voids between, then water could flow through the seawall back down to the beach.

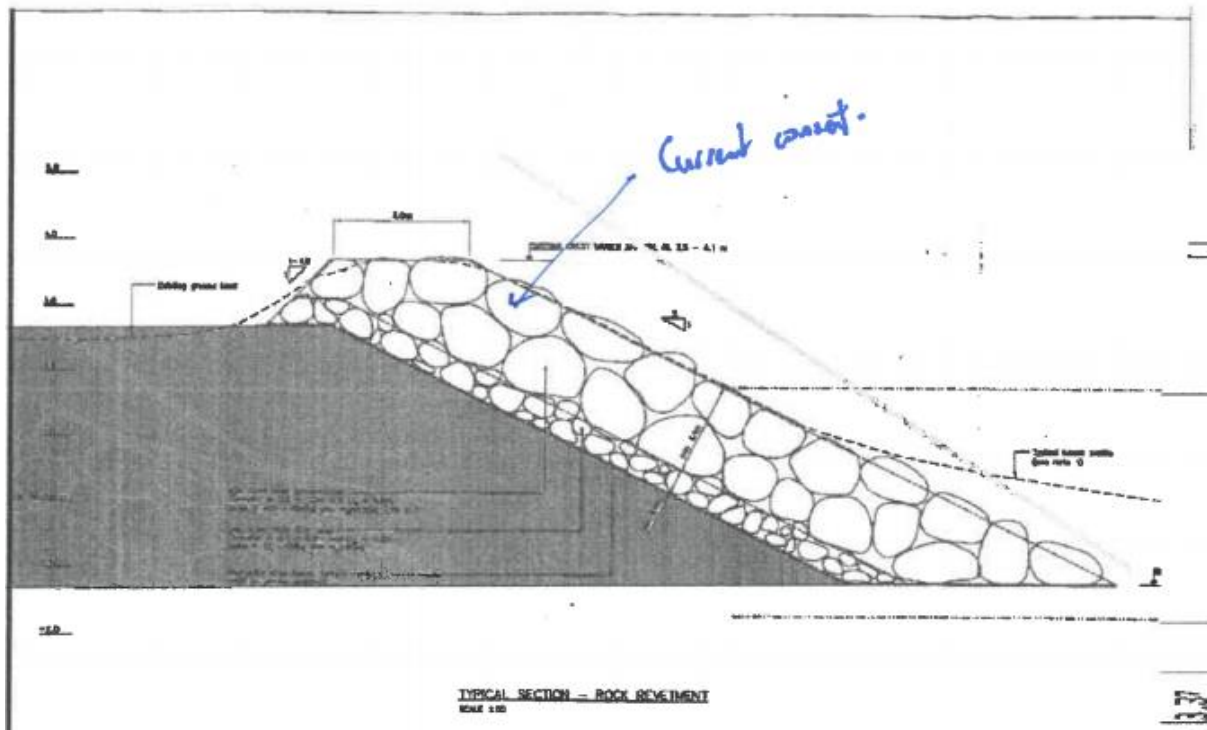
A drawing was presented which showed the sea wall design as per below. We were informed that this was a cross section as per the resource consent for the sea wall. It was suggested that if the wall was built as per this design then water could flow back through the wall via the voids between the rocks.

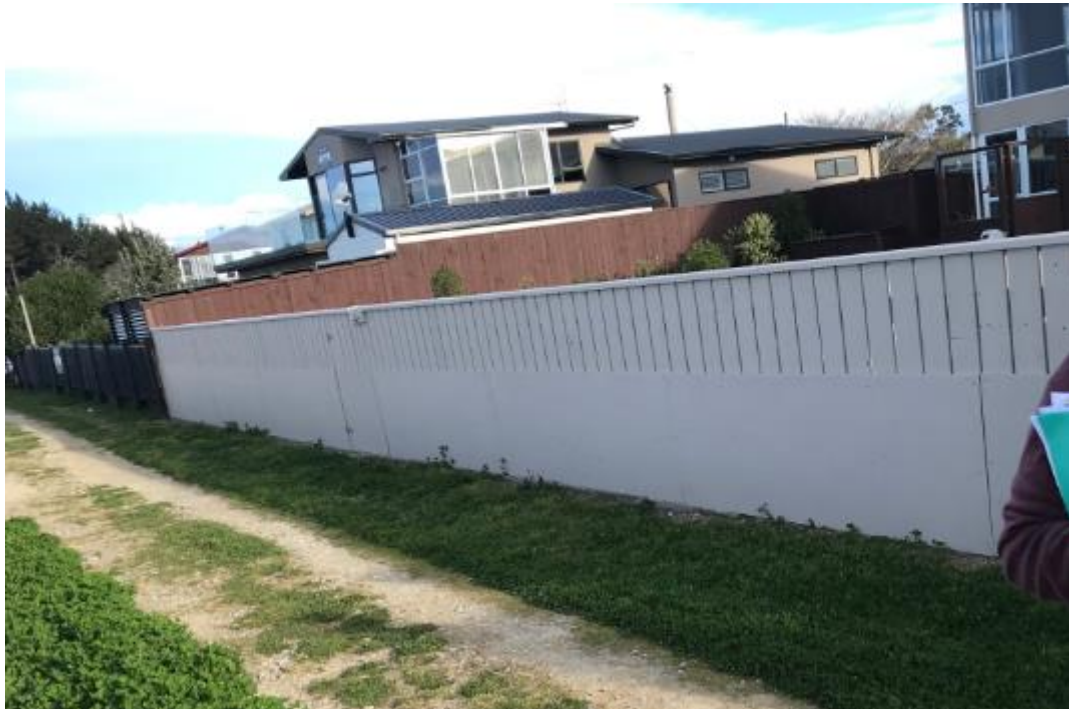
It was suggested that fences erected by residents facing the sea on Broadsea Ave act as a reasonable second line of defence to flooding caused by wave action. Because there is nowhere for the water to go once it gets trapped behind the sea wall and the fences it eventually builds up and floods back out onto Broadsea Ave, then flooding lower lying properties.

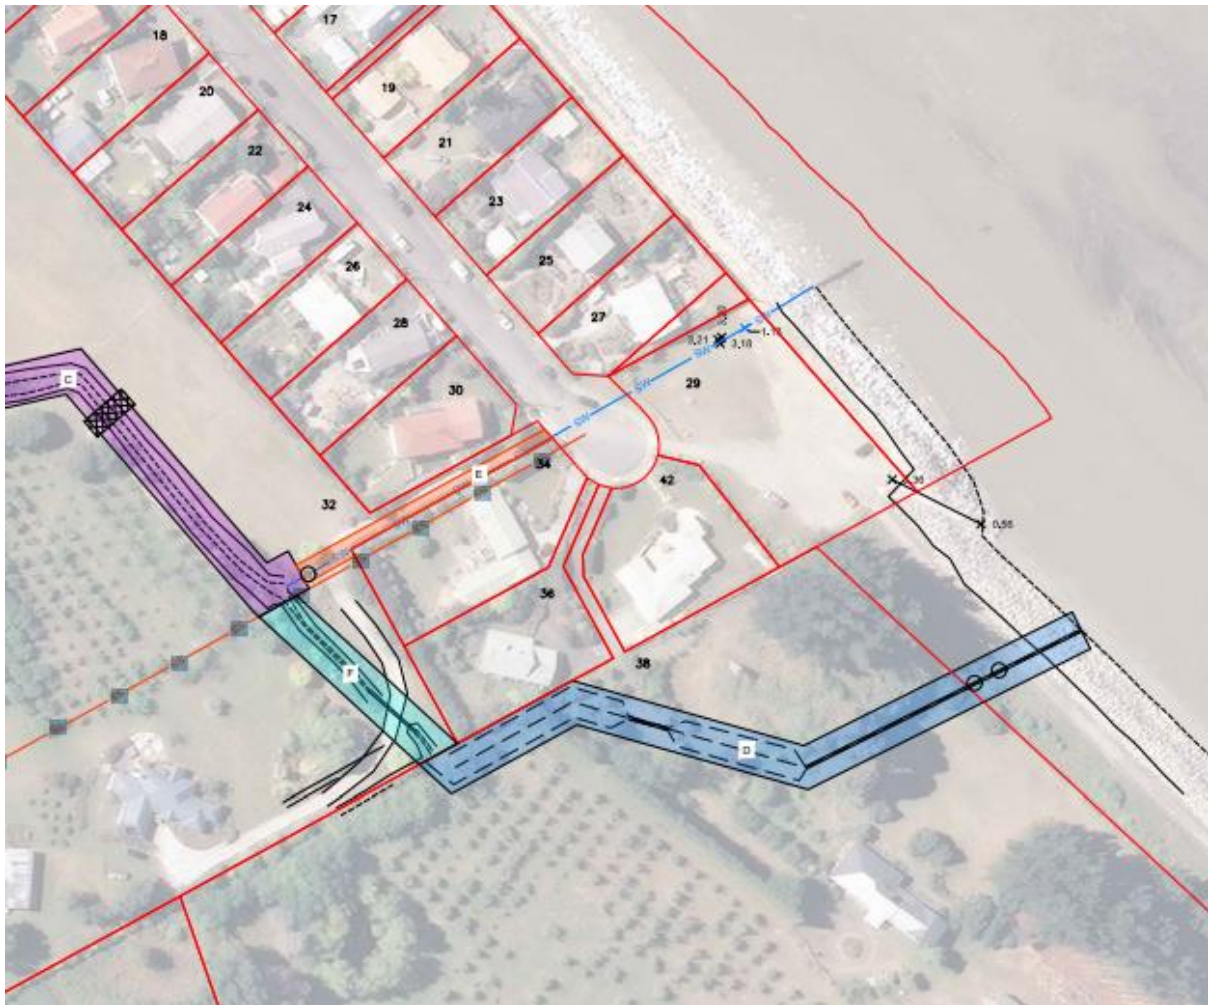
The concept plan that Council have prepared for a second outfall pipe via 38 Broadsea Ave was presented by the landowners that have been party to the easement negotiations (see below). I reported that it had been costed at \$350,000 by the design consultants, and would likely cost more once all costs [including resource consents etc] were factored in. I reported that there wasn't funding for a second outfall pipe and Council were not planning to construct a second outfall pipe at this stage. I reported that a catchment study was programmed for the area, which would better inform the situation with respect to flooding resilience. This would include assessing flow down to the estuary in a southerly direction during flooding. I reported that, even if a second outfall pipe was constructed, the main issue was that the area was low lying and there was inadequate fall to effectively drain the area to sea via overland and piped drainage.

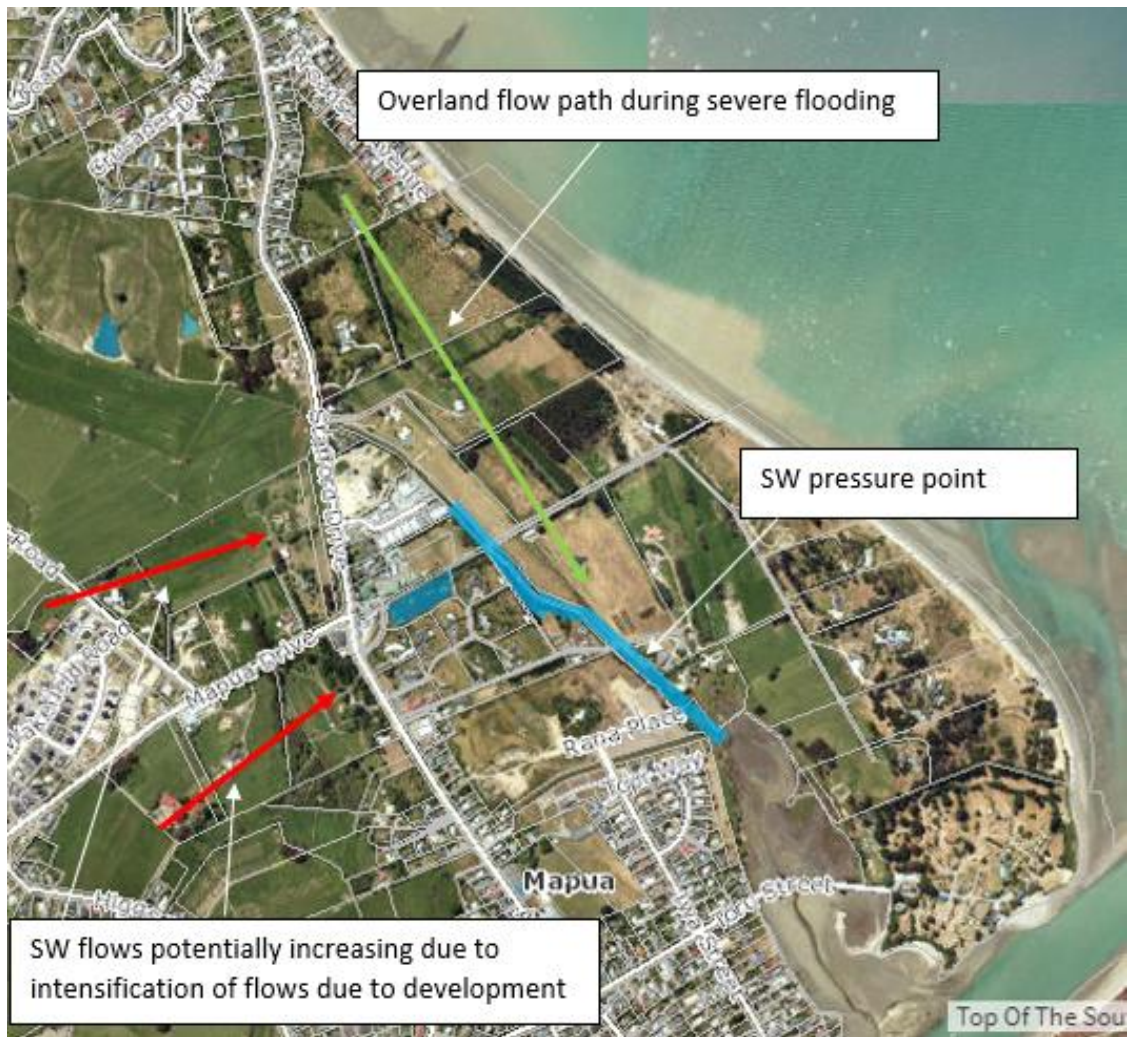
Concern was raised that if there was a plan to direct water down towards the estuary that this would put more pressure on existing drainage out towards the estuary, which was already being pressured by intensification caused by development in Mapua.

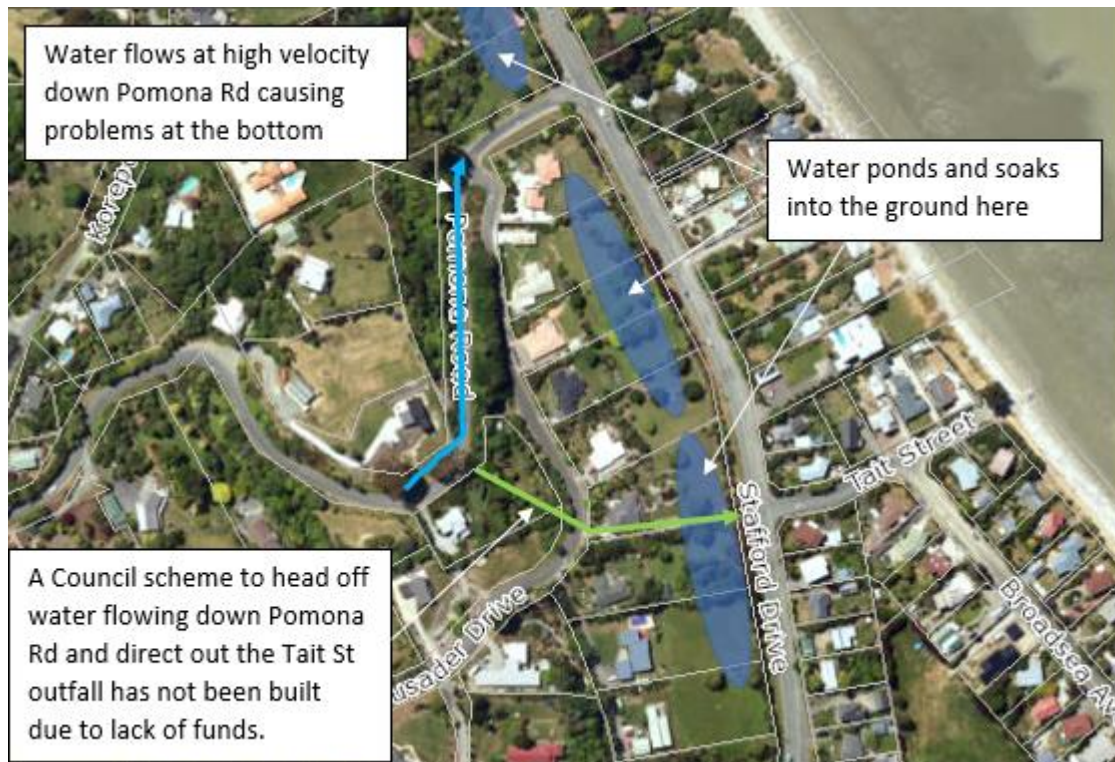
Complaints were made about the soakage of stormwater into properties on the western side of Stafford Drive caused by flow off subdivisions on the hill. In particular it was felt that Separable Portion 2 of a previous Council stormwater project, to collect and direct flows off Pomona Road and out into the Tait St outfall under pressure, should be completed. It was felt that an elevated groundwater table caused by soakage of stormwater was exacerbating surface flooding of properties in rainfall events.

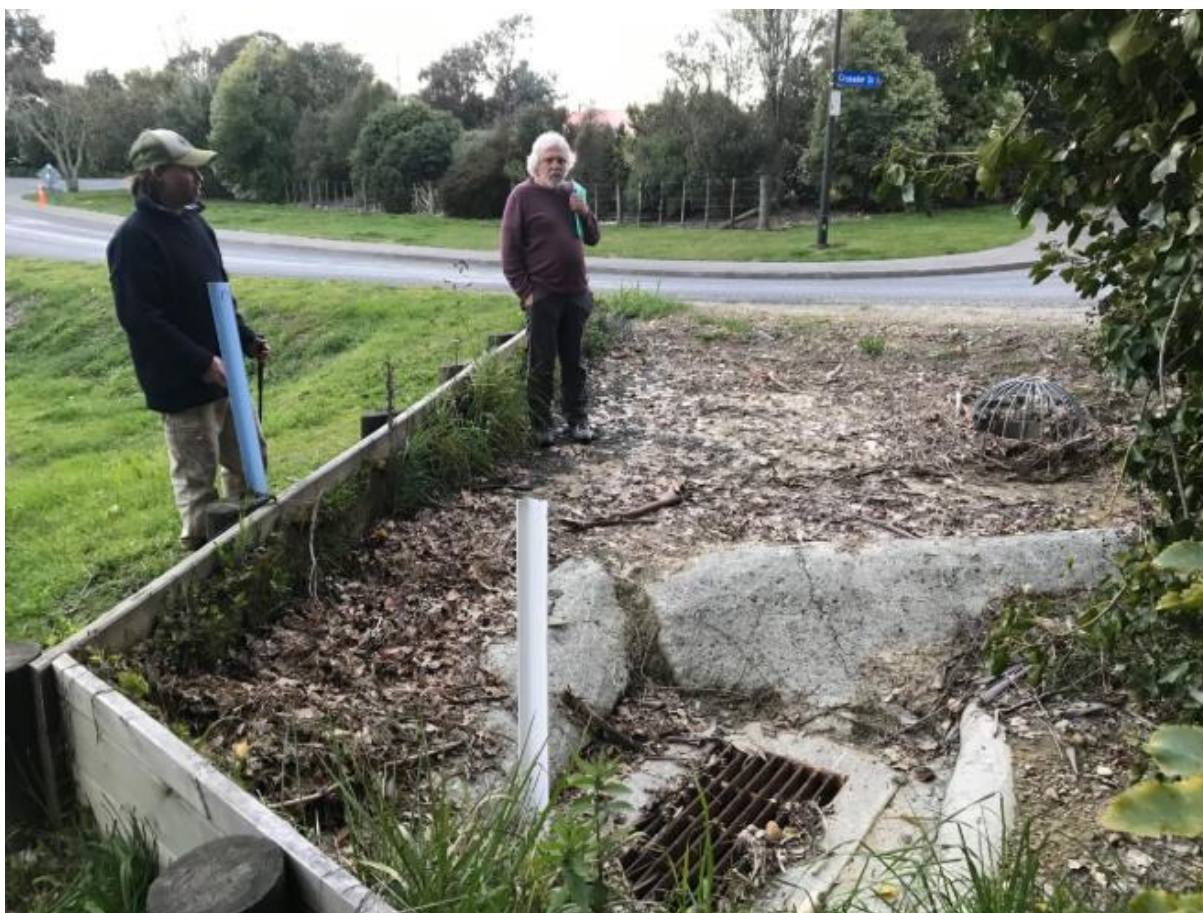
It was reported that the drain at the bottom of Pomona Rd is often blocked and last time it was reported it took Downers 2 months to get to site to clear because other work was prioritised.

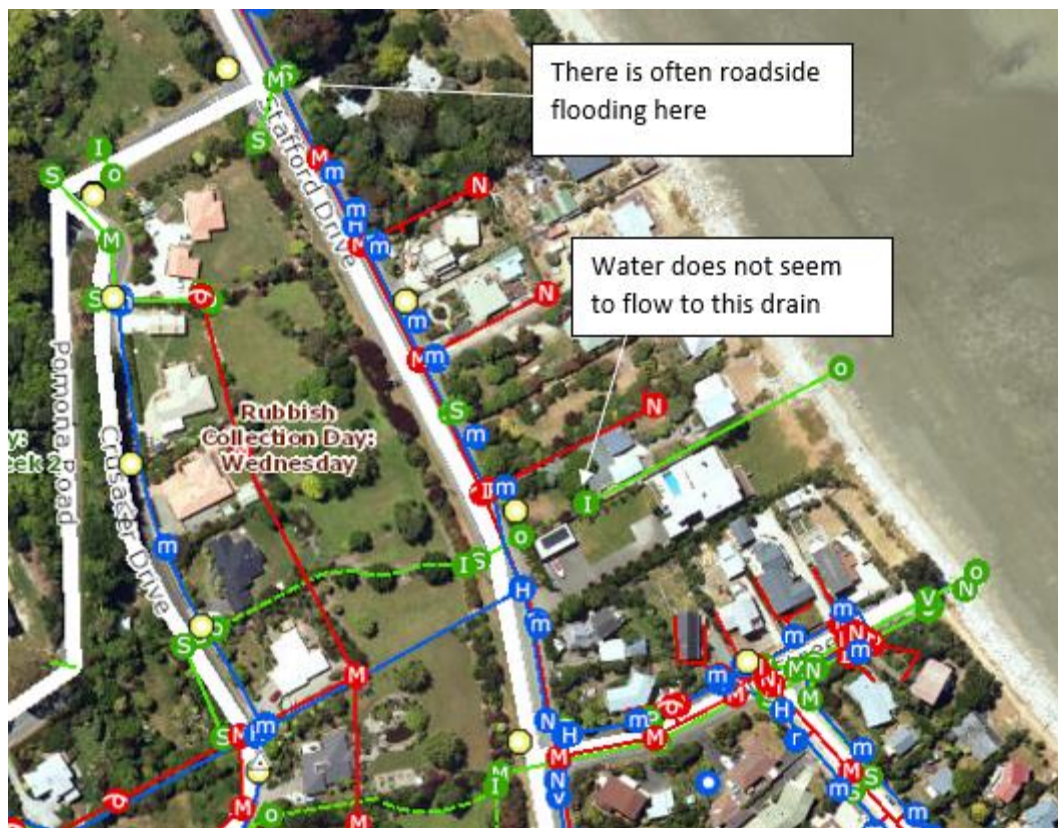
Issues were reported as per the marked up photo below.
