20 December 2019

### **Ruby Bay Drainage Issues**

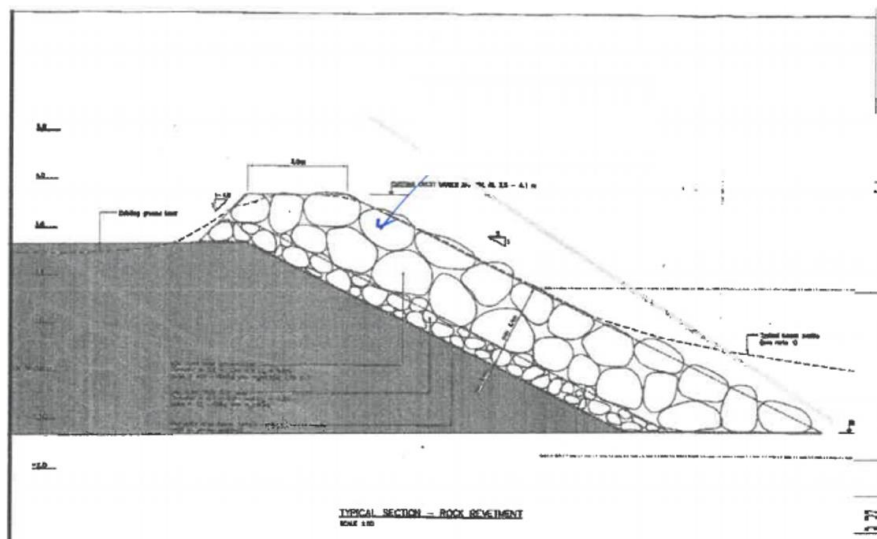
Figure 1

Attendees presented a drawing which showed the sea wall design as per below (Figure 1). Attendees were of the view that this was a cross section as per the resource consent for the sea wall. They suggested that if the wall was built as per this design then water could flow back through the wall via the voids between the rocks.

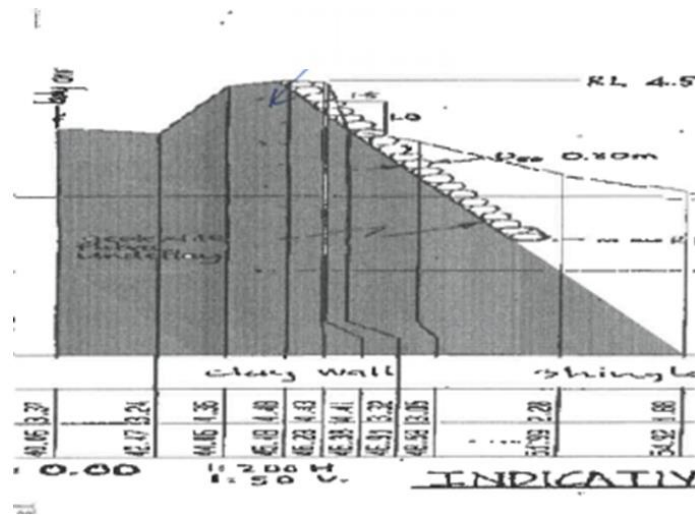
Figure 2

Attendees also presented another drawing (Figure 2 below) which more closely represents the current sea wall construction. They indicated that this was from the old resource consent which had expired. This shows a clay core wall with rock armour over.

Council response: The existing wall is compliant with its resource consent as detailed in the Engineering Services Committee report dated 4 July 2019. (The existing wall is similar in construction to Figure 2.) No reconstruction or major changes to the existing clay core wall was envisaged or planned as part of the process for the current resource consent.

The Council's Coastal Scientist, and Rivers & Coastal Engineer, have assessed the proposal to introduce voids into the existing clay core. They are both of the opinion that in an event like ex-cyclone Fehi the ability for seawater behind the wall to drain back through any voids will be less than the quantity of water surging over the wall and through the voids. They consider it is likely that introducing voids would result in more seawater getting behind the wall during the event. Reconstructing the wall to introduce voids would involve significant work and expense. A thorough investigation would be required to evaluate this proposal in detail.

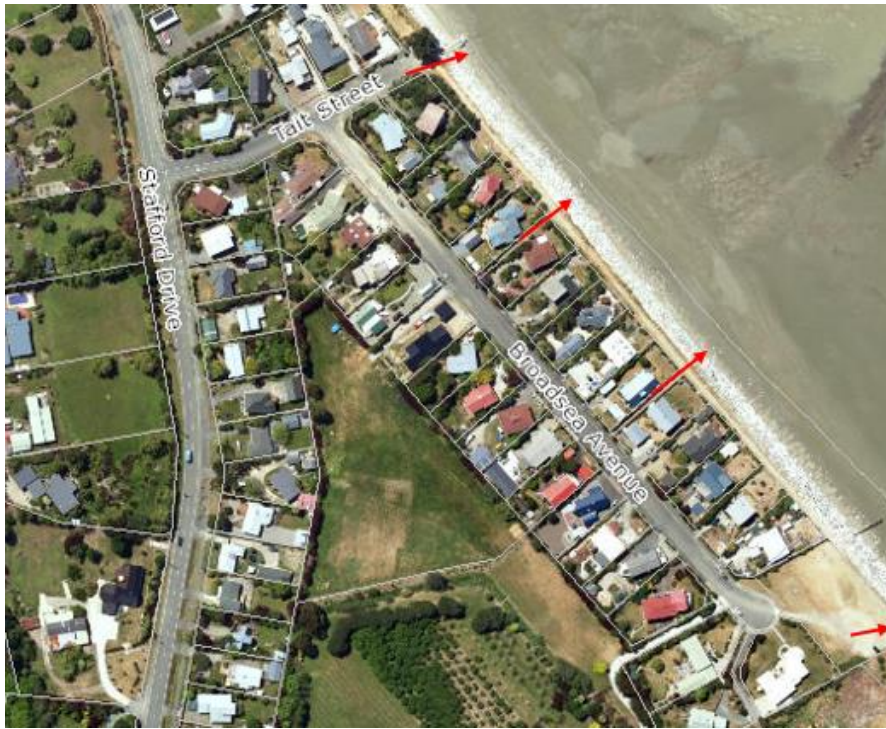
Comment from meeting: An attendee suggested that additional stormwater drains could be laid down the two alleyways off Broadsea Ave to improve drainage off the street. (See Figure 3 and Figure 4.)

Figure 3 – Attendee-proposed location of additional stormwater drains

Council response: Additional stormwater drains cannot be installed in isolation. They would need to be properly investigated and designed as part of a wider assessment of coastal protection and drainage in the Ruby Bay area.

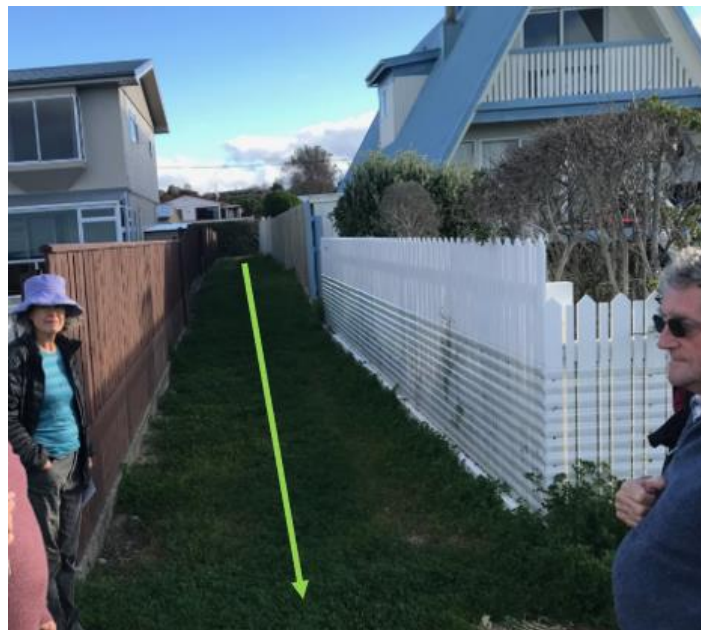
Figure 4 – Walkway between Broadsea Ave and sea wall

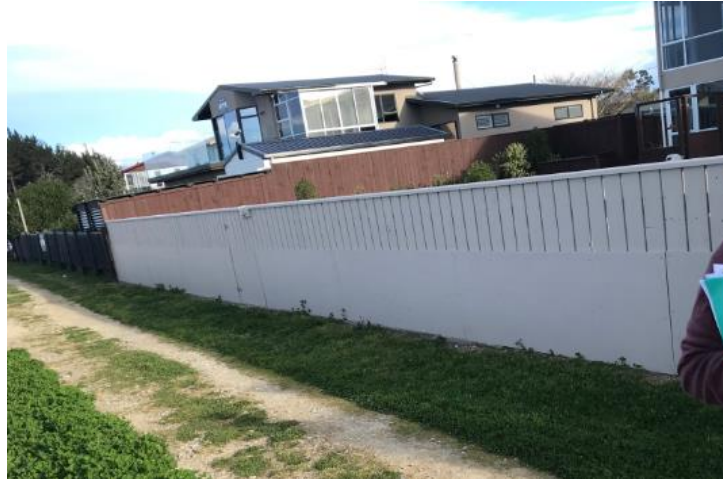
Comment from meeting: Attendees suggested that fences erected by residents facing the sea on Broadsea Ave act as a reasonable second line of defence to flooding caused by wave action (see Figure 5). Because there is nowhere for the water to go once it gets trapped behind the sea wall and fences it eventually builds up and floods back out onto Broadsea Ave, then flooding lower lying properties.

Figure 5 – Fences adjacent to sea wall

Council response: A decision on these suggestions is linked with wider assessment of coastal protection and drainage management. Constructing a new bund, in isolation, may transfer the problem elsewhere. It needs to be part of the wider assessment.

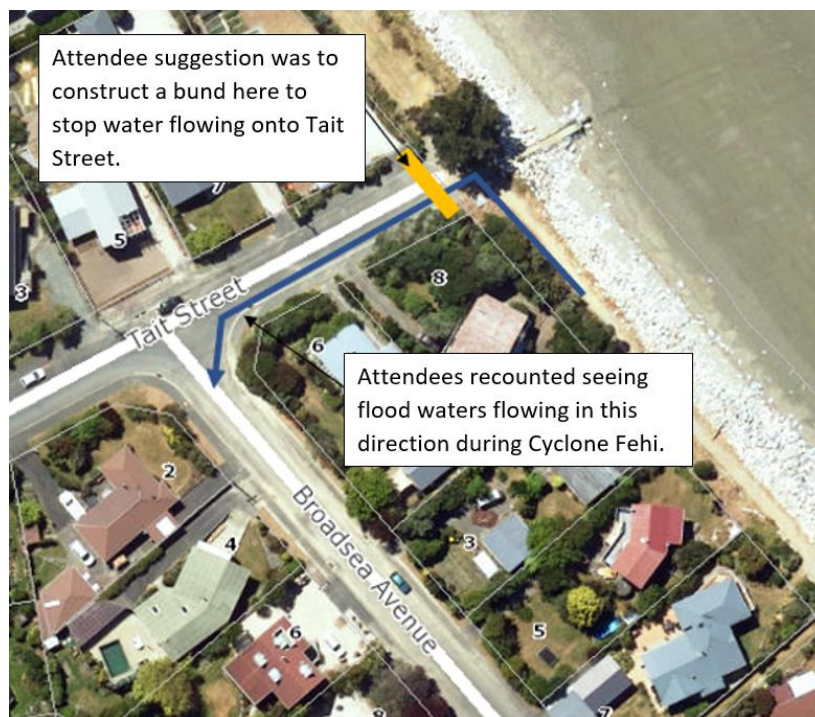
Attendees suggested that a small bund at the end of Tait St could be constructed to stop water flowing onto Tait St and Broadsea Ave from behind the wall. During Cyclone Fehi attendees recounted that this was the route that a lot of the flood water took onto Broadsea Ave (see Figure 6).

Figure 6 – Attendee-proposed bund location

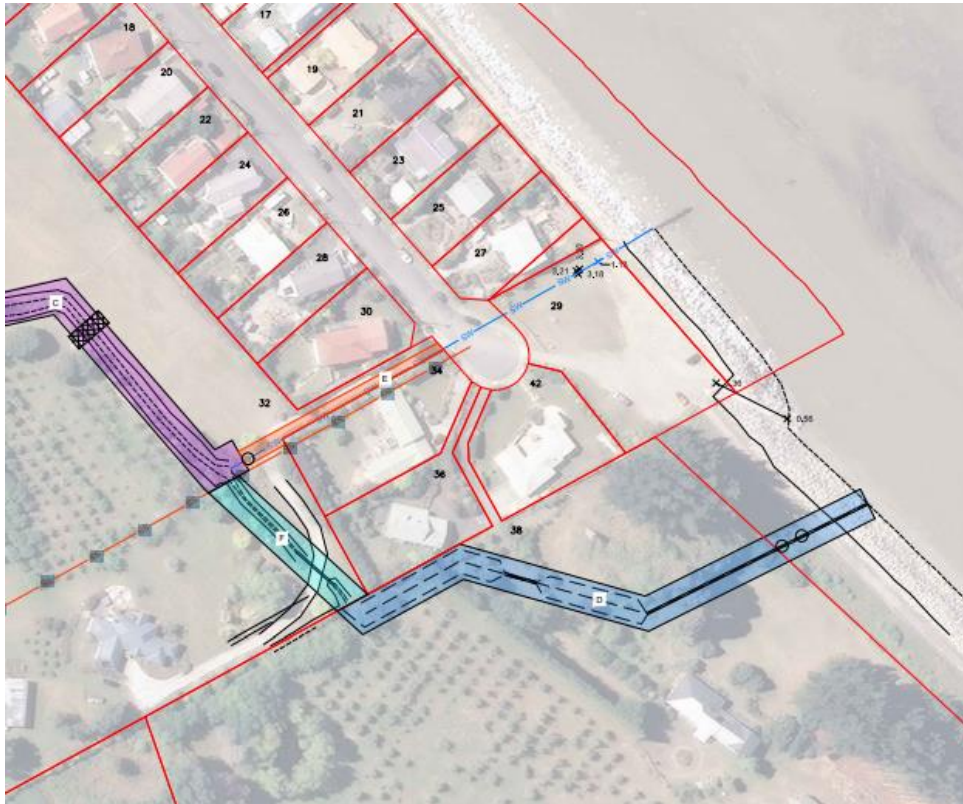
Attendees presented a concept plan that Council have prepared for a second outfall pipe via 38 Broadsea Ave (see below). Rob O'Grady reported that it had been costed at \$350,000 by the design consultants, and would likely cost more once all costs (including resource consents) were factored in. Rob O'Grady reported that there wasn't funding for a second

Figure 7 – Concept plan for second outfall pipe from 38 Broadsea Ave

Council response: This proposal would also need to be considered as part of the wider coastal protection assessment and drainage management for this area. The present design capacity of outfall pipes in relation to rainfall was looked at with project upgrades in 2010. We understand that the combination of outfall flow rates and detention, the flooding from rainfall is not above habitable floor levels but with sea levels high this could become the determining factor.

The option and funding of the 2nd outfall was dropped in favour of an alternative option of draining to the south. These two options have yet to be compared. In the meantime we have prioritised improving drainage capacity to the existing outfall pipe. We are finalising easements for the existing drains so that we can maintain them.

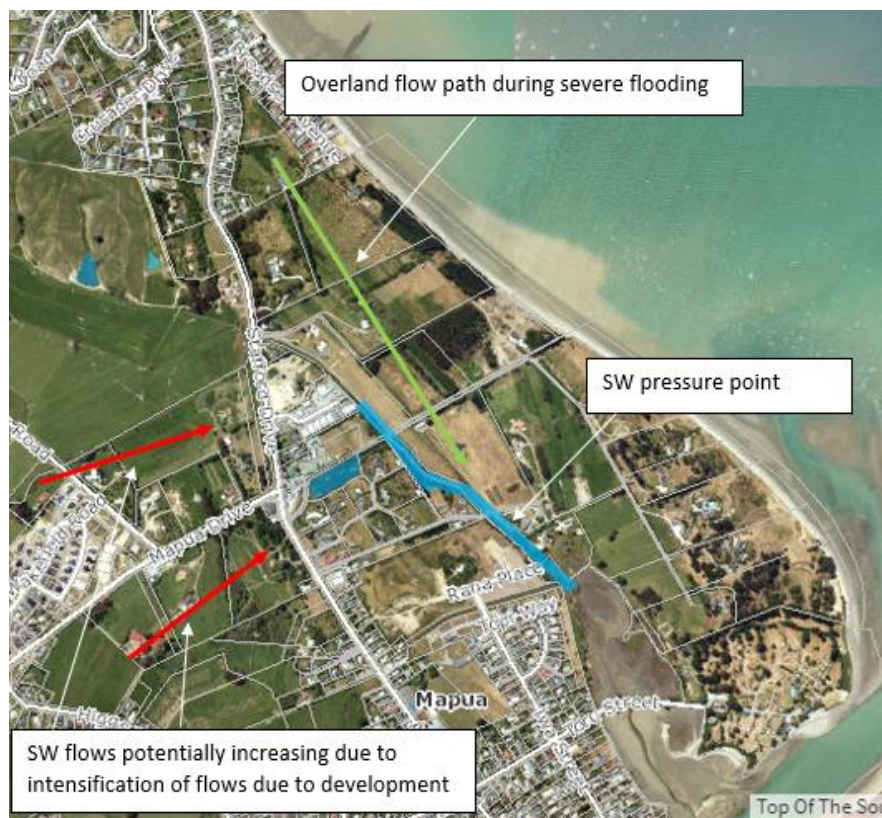
Comment from meeting: Concern was raised that if there was a plan to direct water to the south, down towards the estuary, that this would put more pressure on existing drainage out towards the estuary, which was already being pressured by intensification caused by development in Mapua.

Figure 8 – Intensification of flows towards the estuary as described by meeting attendees

Council response: We are presently modelling Mapua and Ruby Bay, with the initial results from the model expected in early 2020. This information will be used in developing a Catchment Management Plan for the Mapua and Ruby Bay area. This will determine where

and when improvements need to be done and whether it is appropriate to direct flows to the south.

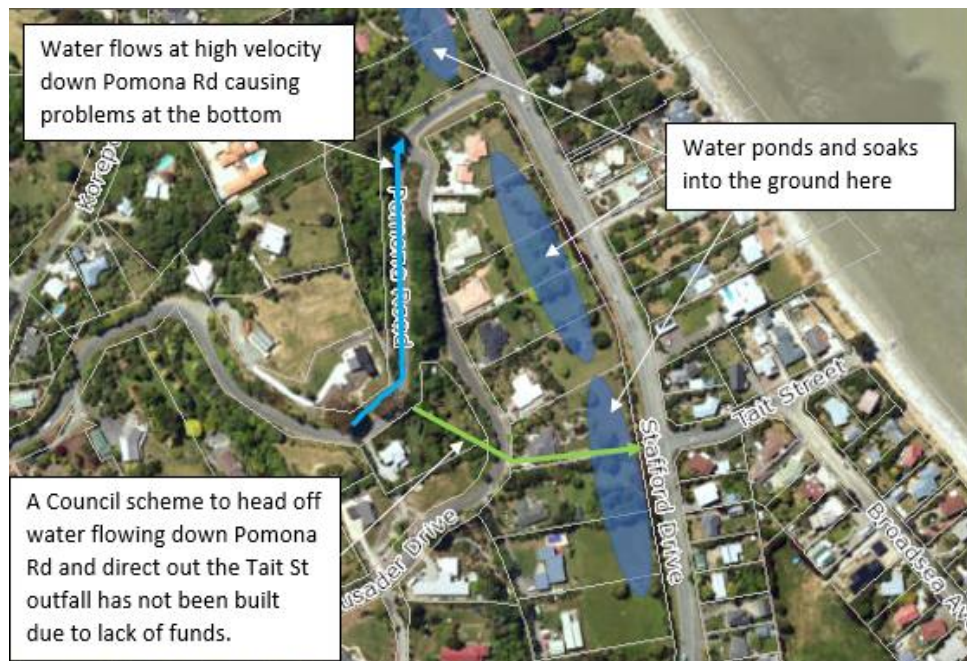
Comment from meeting: Attendees complained about the soakage of stormwater into properties on the western side of Stafford Drive caused by flow off subdivisions on the hill. (See Figure 9.) In particular it was felt that Separable Portion 2 of a previous Council stormwater project, to collect and direct flows off Pomona Road and out into the Tait St outfall under pressure, should be completed. It was felt that an elevated groundwater table caused by soakage of stormwater was exacerbating surface flooding of properties in rainfall events.

Figure 9 – Ponding of water on western side of Stafford Drive

Council response: The Separable Portion 2 project objective was to divert flows from the detention area but insufficient funding was available. This work was a lower priority as the area is designed as a flood detention area and the risk of flooding habitable floors is low. The priority and effectiveness of the Separable Portion 2 will be assessed in the current modelling work. There may be an opportunity to deliver this work in the short term if the effectiveness is shown and funding allows.

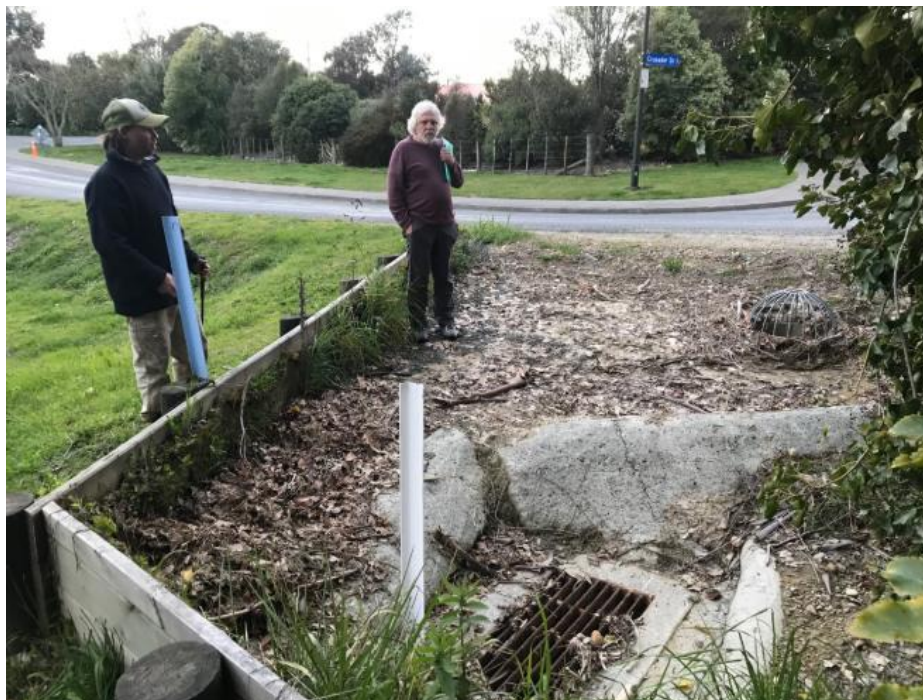
Comment from meeting: Attendees reported that the drain at the bottom of Pomona Rd is often blocked and last time it was reported it took Downers 2 months to get to site to clear because other work was prioritised.

Figure 10 – Drain at the bottom of Pomona Rd

Council response: This inlet has been added to the stormwater contract schedule and will be checked and cleared more regularly.

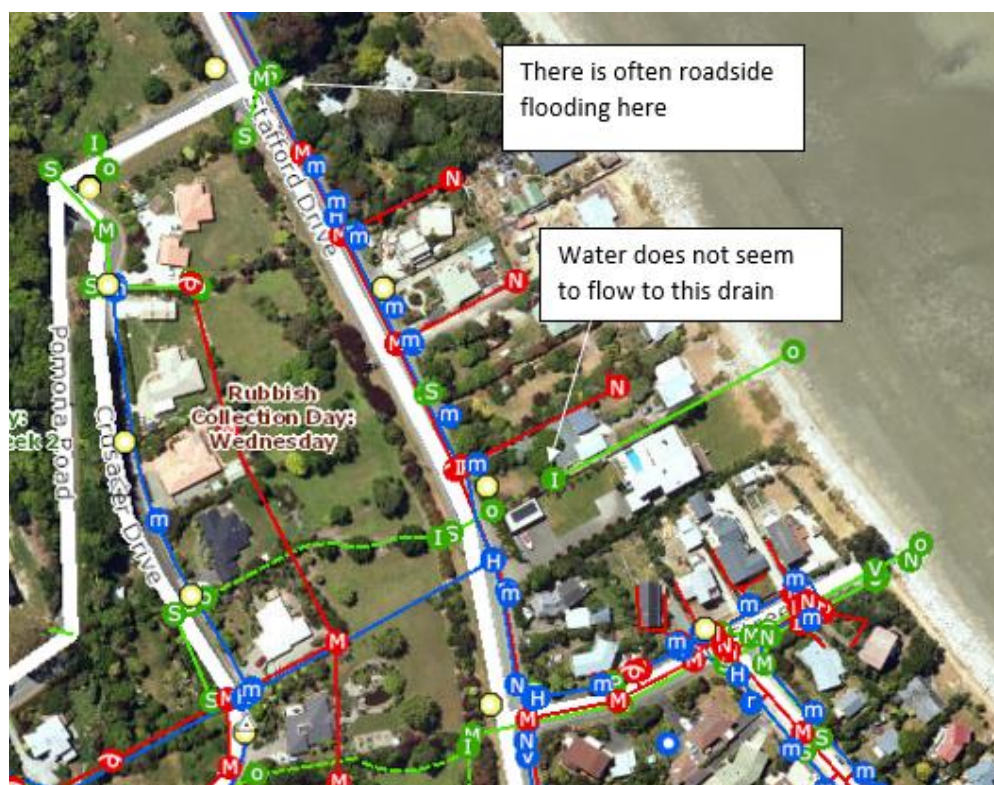
Comments from meeting: Attendees reported issues as per the marked up photo in Figure 11.

Figure 11 – Drainage issues on Stafford Drive

- The soakpit opposite Pomona Road offered limited functionality and because of this an overflow was added in 2012. We have recently checked and cleaned this soakpit to improve capacity.
- Staff visited 118 Tait St and the open drain shown on plans appears to have been filled in. We will continue to investigate this further, but note that the outlet is prone to gravel blockage.
